## Stranding of the Motor Vessel Vine 3 off Maiden Island, Antigua 1 May 2015

### **Synopsis**

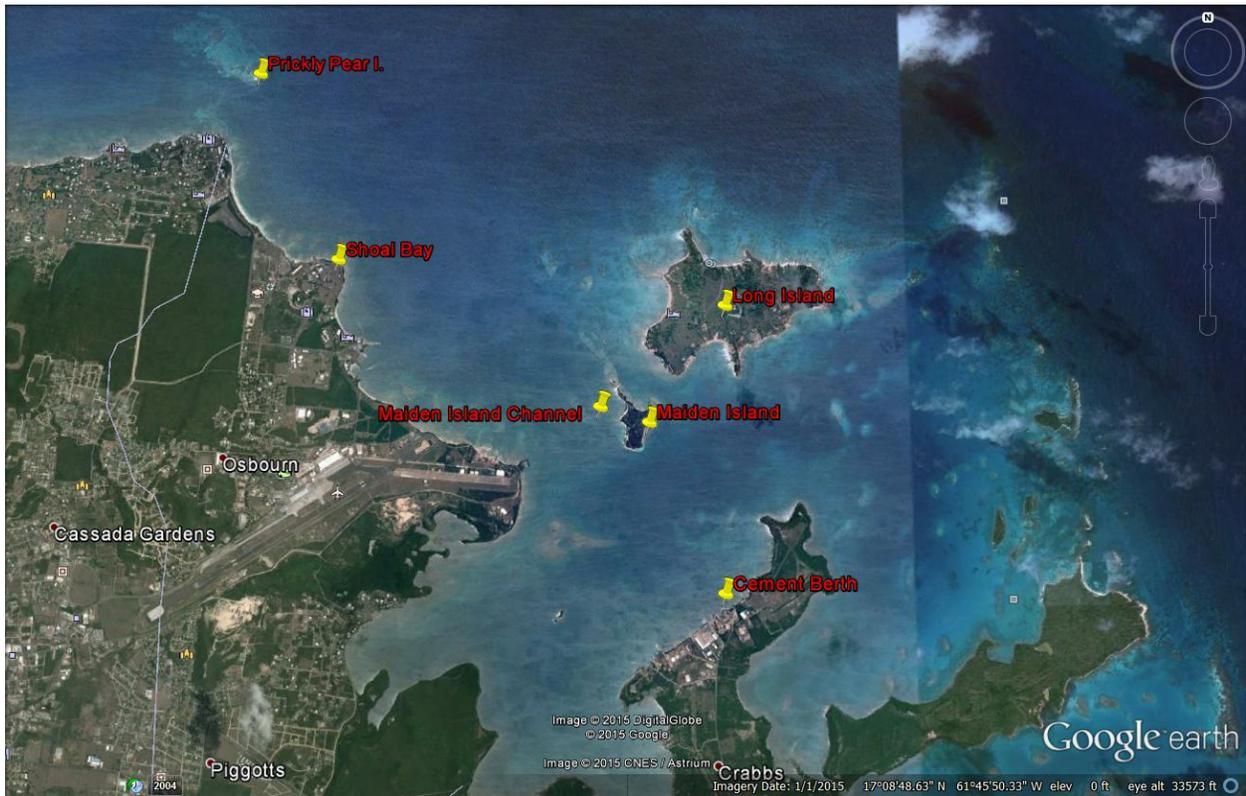
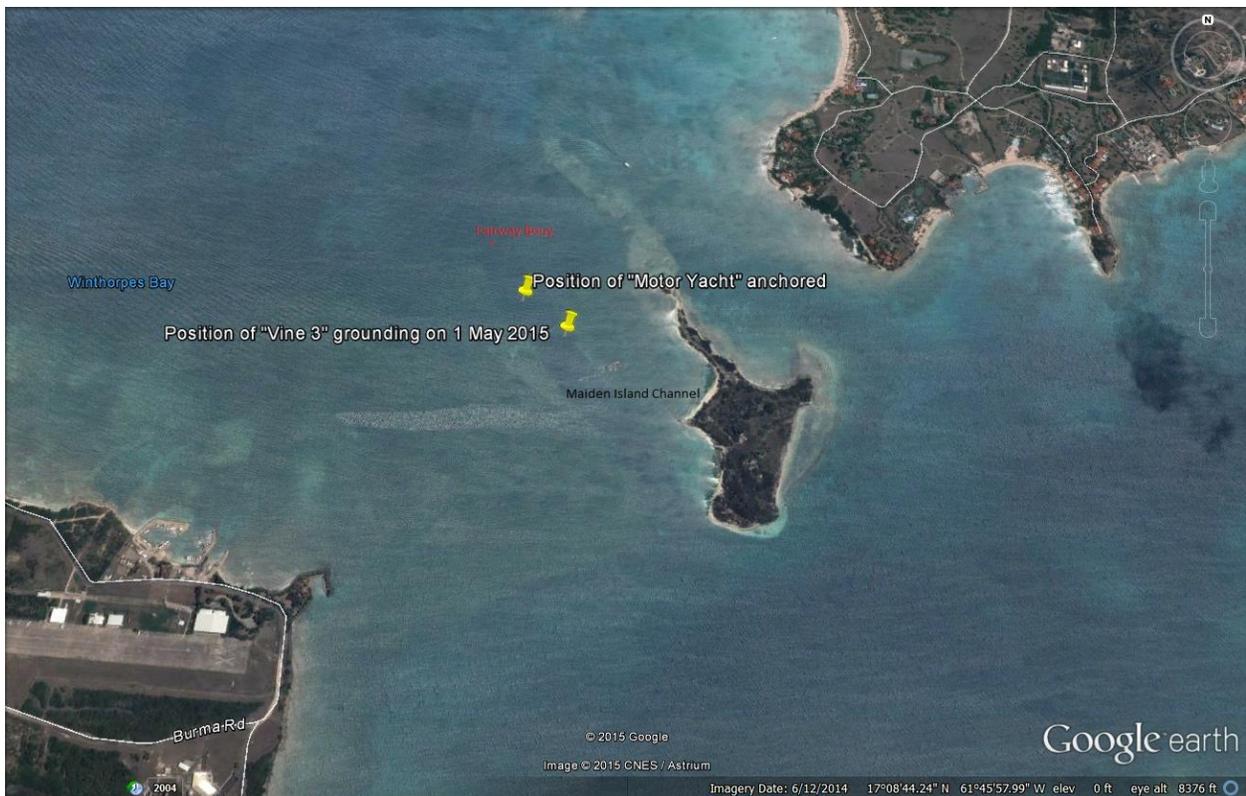
Overview of the area

The charted depth of the Maiden Island channel is 5.5m, with a narrowest width of 50 metres. It was noted that the location of the Eastern side of the Channel appeared slightly more to the East on the AIS data obtained from IHS Maritime & Trade's AIS live site than is indicated on the Admiralty Chart Number 2065.
